Highways England

Area 7

The Challenge

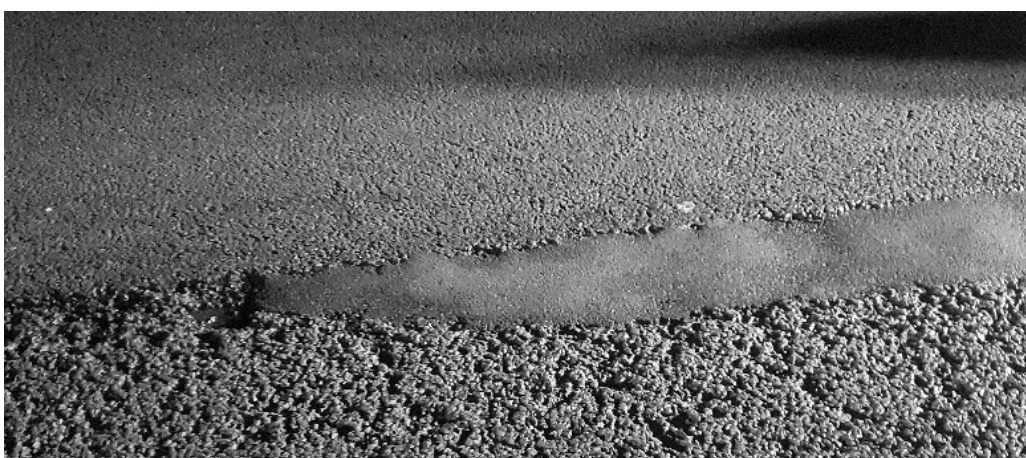
Amey's contract to maintain Highways England Area 7 in the East Midlands involves 370km of highways in the East Midlands, including stretches of some of the UK's busiest motorways. On the M1, near junction 22, Amey was facing a reoccurring problem with a longitudinal joint around 16m long which kept opening up, despite repeated attempts to repair it.

Amey had tried a variety of methods, including a specialist cold pothole repair system, but each time the new material failed to bond properly to the sides of the crack. This meant that water got into the repair and the joint opened up once more.

Thermal Road Repair's (TRR's) patented system works by heating up material in and around a defect, mixing the heated material with a small amount of new asphalt mix and then compacting it. The level of heat applied is monitored and automatically controlled so that the bitumen within the existing road is not overheated and damaged through oxidation.

The result of this process is an area of homogeneous material, with no cold joints. This means that there are no remaining cracks or joints through which water can enter, so that the treated zone will last as long as the surrounding pavement.

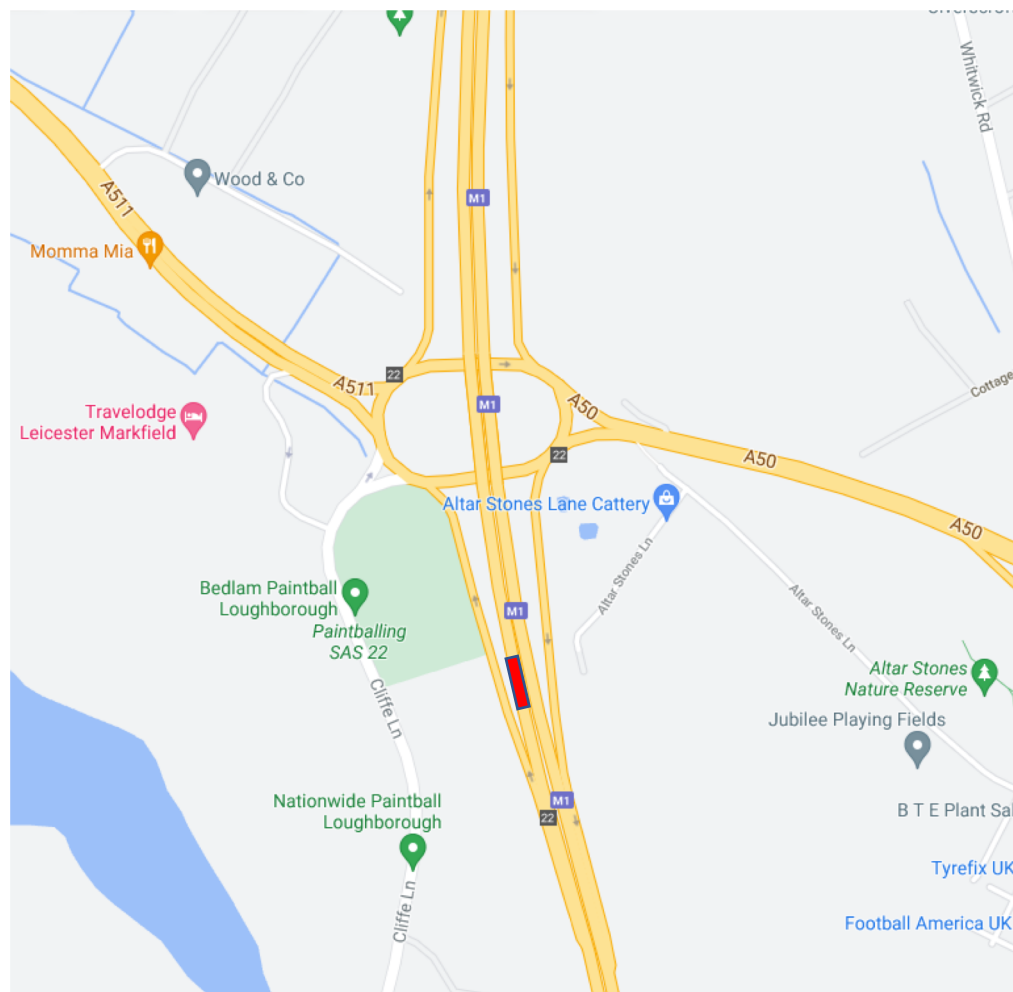
Repair Details

The failing longitudinal joint was on the M1 Northbound at Junction 22, between lanes 1 and 2.
